Manhole Inspection Summary

Manhole # S270__013MH

Insp Date: **4/29/08 9:20 AM**

Location Address: **1100 w ostend st**

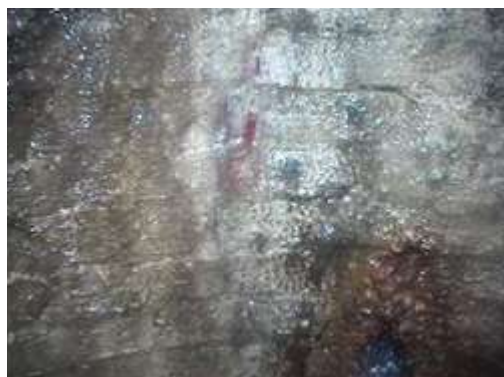
Defect 8

signs of infiltration barrel -corbel

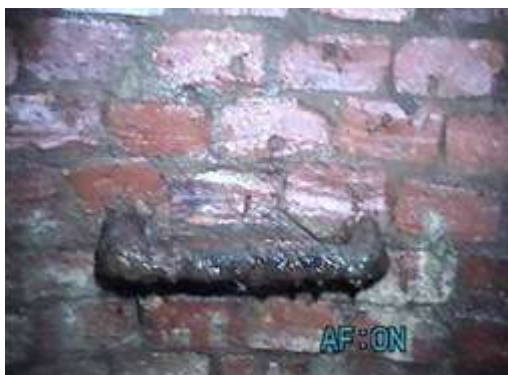
Defect 7

signs of surcharge on steps

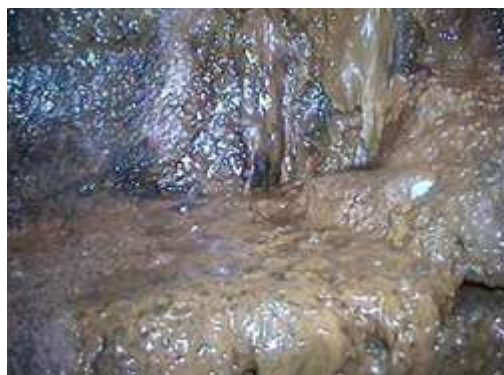
Defect 4

infiltration barel/sediment build up in barrel and bench

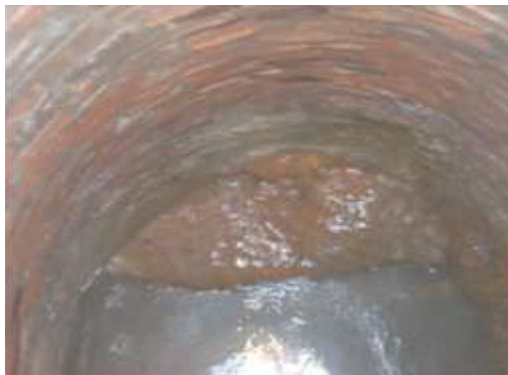
Defect 2

debris on bench, signs of surcharge

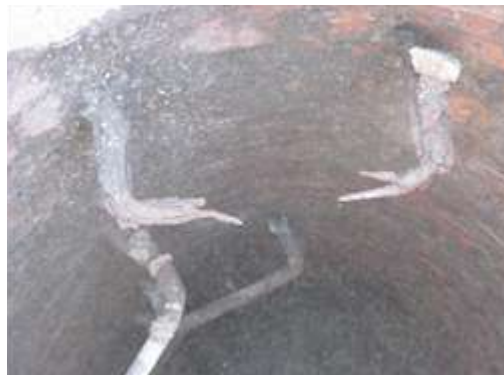
Defect 1

rusted broken rung/ Infiltration in the corbel

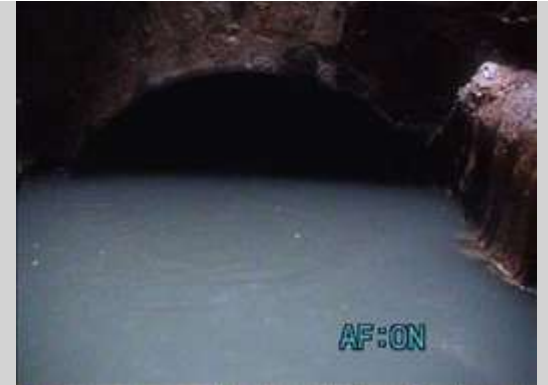
12 O'Clock Outflow

Pipe Height: **28.8** (in.) Rod and Bar (Angled)
Pipe Material: **Clay** ☐ Pipe Lined
Invert Depth: **14.79** (ft.) Flow Characteristics: **Slow**
Deposits: ☒ None ☐ Mud ☐ Sludge ☐ Debris ☐ Grease
Silt Depth: **0** (in.) Deposits Extent:
Infiltration: **Evidence** Pipe Seal Cond: **Unknown**

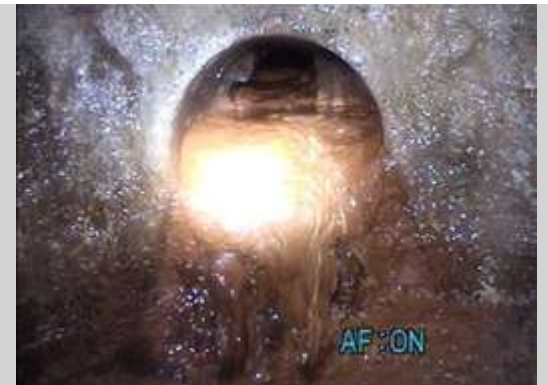
3 O'Clock Inflow

Pipe Height: **12** (in.) Rod and Bar (Angled)
Pipe Material: **Clay** ☐ Pipe Lined
Invert Depth: **11.90** (ft.) Flow Characteristics: **Slow**
Deposits: ☐ None ☐ Mud ☒ **Sludge** ☐ Debris ☐ Grease
Silt Depth: **3** (in.) Deposits Extent: **Heavy**
Infiltration: **Evidence** Pipe Seal Cond: **Unknown**

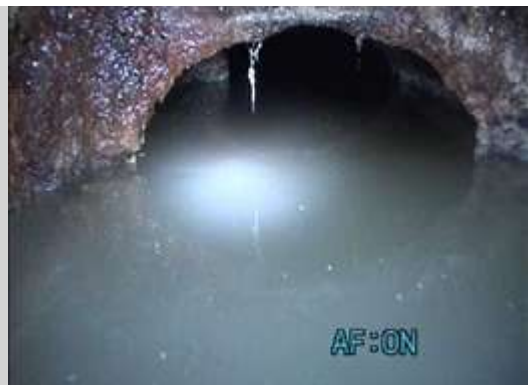
6 O'Clock Inflow

Infiltration: **Evidence** Pipe Seal Cond: **Unknown**
